RE: Revised Vapor Intrusion Report
Former Solutia – John F. Queeny Plant
St. Louis, Missouri
EPA ID No. MOD 004 954 111

**VAPOR INTRUSION
WORK PLAN IMPLEMENTATION REPORT**

Former Solutia Queeny Plant

St. Louis, Missouri

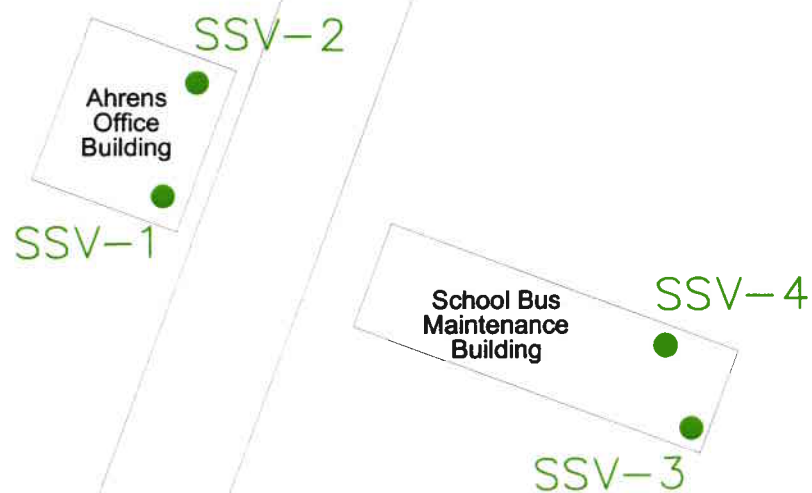
Figure 3

**Sub-Slab Vapor
Sample Locations**
Former Solutia Queeny Plant
Saint Louis, Missouri
